NASA Technical Memorandum 105939

Sliding Durability of Candidate Seal Fiber Materials in Hydrogen from 25 to 900 °C

Christopher DellaCorte and Bruce M. Steinetz
*Lewis Research Center
Cleveland, Ohio*

March 1993

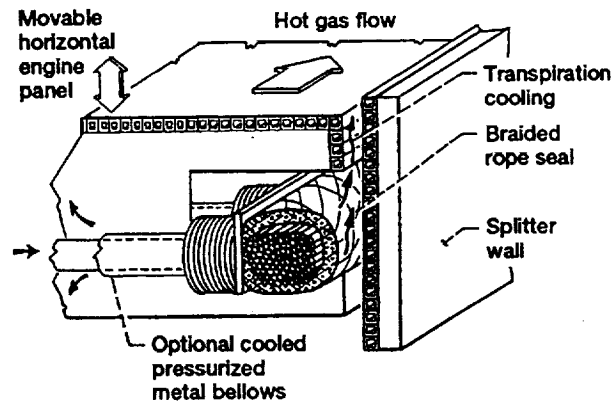
Figure 1.—Cross section of proposed engine seal.

Novel seal designs have been developed at NASA Lewis Research Center to address high temperature dynamic sealing applications on hypersonic vehicles. One design approach uses a flexible woven rope seal to prevent leakage between adjacent panels which must articulate relative to one another, for example, engine sidewall seals (fig. 1). To minimize seal actuation forces and seal damage, the tribology (friction and wear behavior) of the system is a critical design issue.

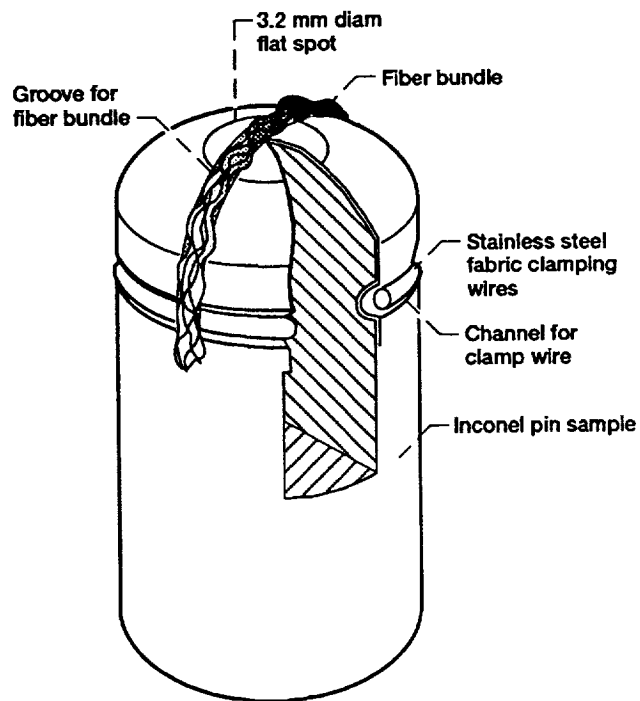
Figure 2.—Pin test specimen.

The candidate fibers are tested in sliding using a pin-on-disk apparatus. This testing technique, which has been described elsewhere (ref. 2) consists of wrapping a bundle of fibers (typically 6000, $\approx 10\text{-}\mu\text{m}$ diameter fibers) over the tip of a specially machined Inconel 718 pin. The pin has grooves machined into its tip and shank to accept the bundle and prevent its slipping off during testing (fig. 2). In addition, a 3.2-mm diameter flat spot is machined on the pin tip to provide a uniform sliding area. The bundle is given a one half or 180° twist across the flat contact spot to help contain the bundle in the sliding contact and to orient the fibers at approximately a 45° angle with the sliding direction to better simulate proposed braided seal configurations (fig. 3). Figure 4 shows a photomicrograph of a wrapped pin sample prior to testing.

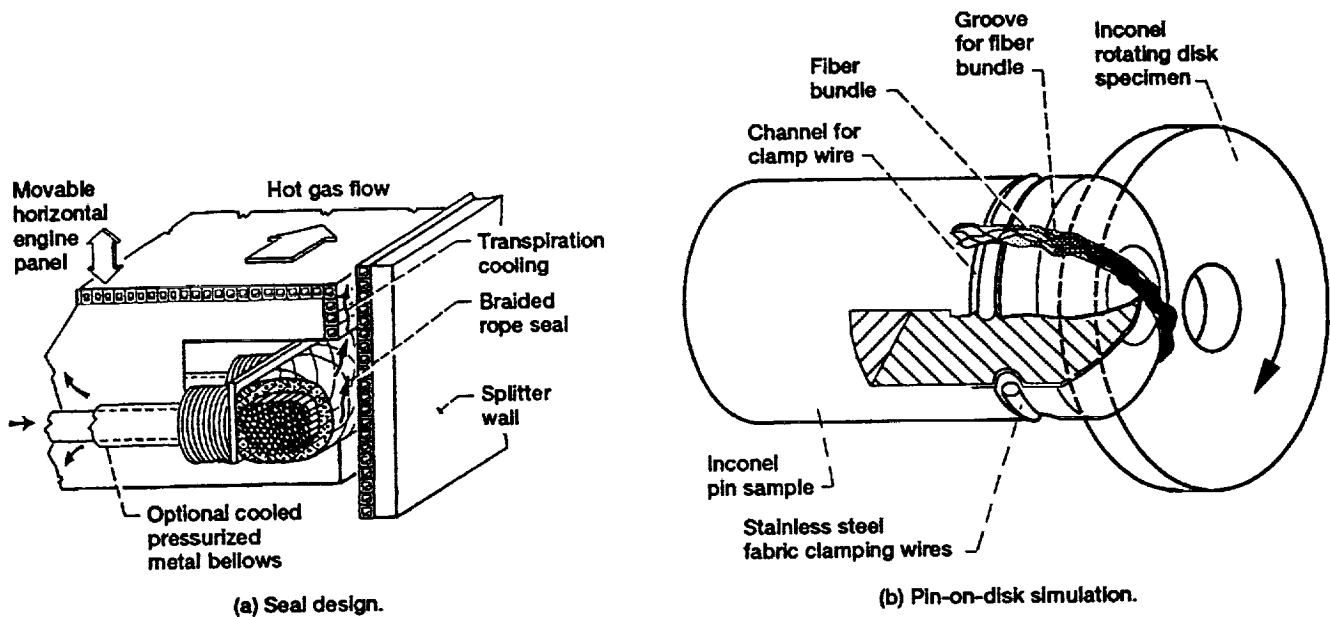
Figure 3.—Fiber tow wrapped over pin is slid against a slowly rotating disk (shown on right) to simulate seal/counterface sliding in application (shown on left).

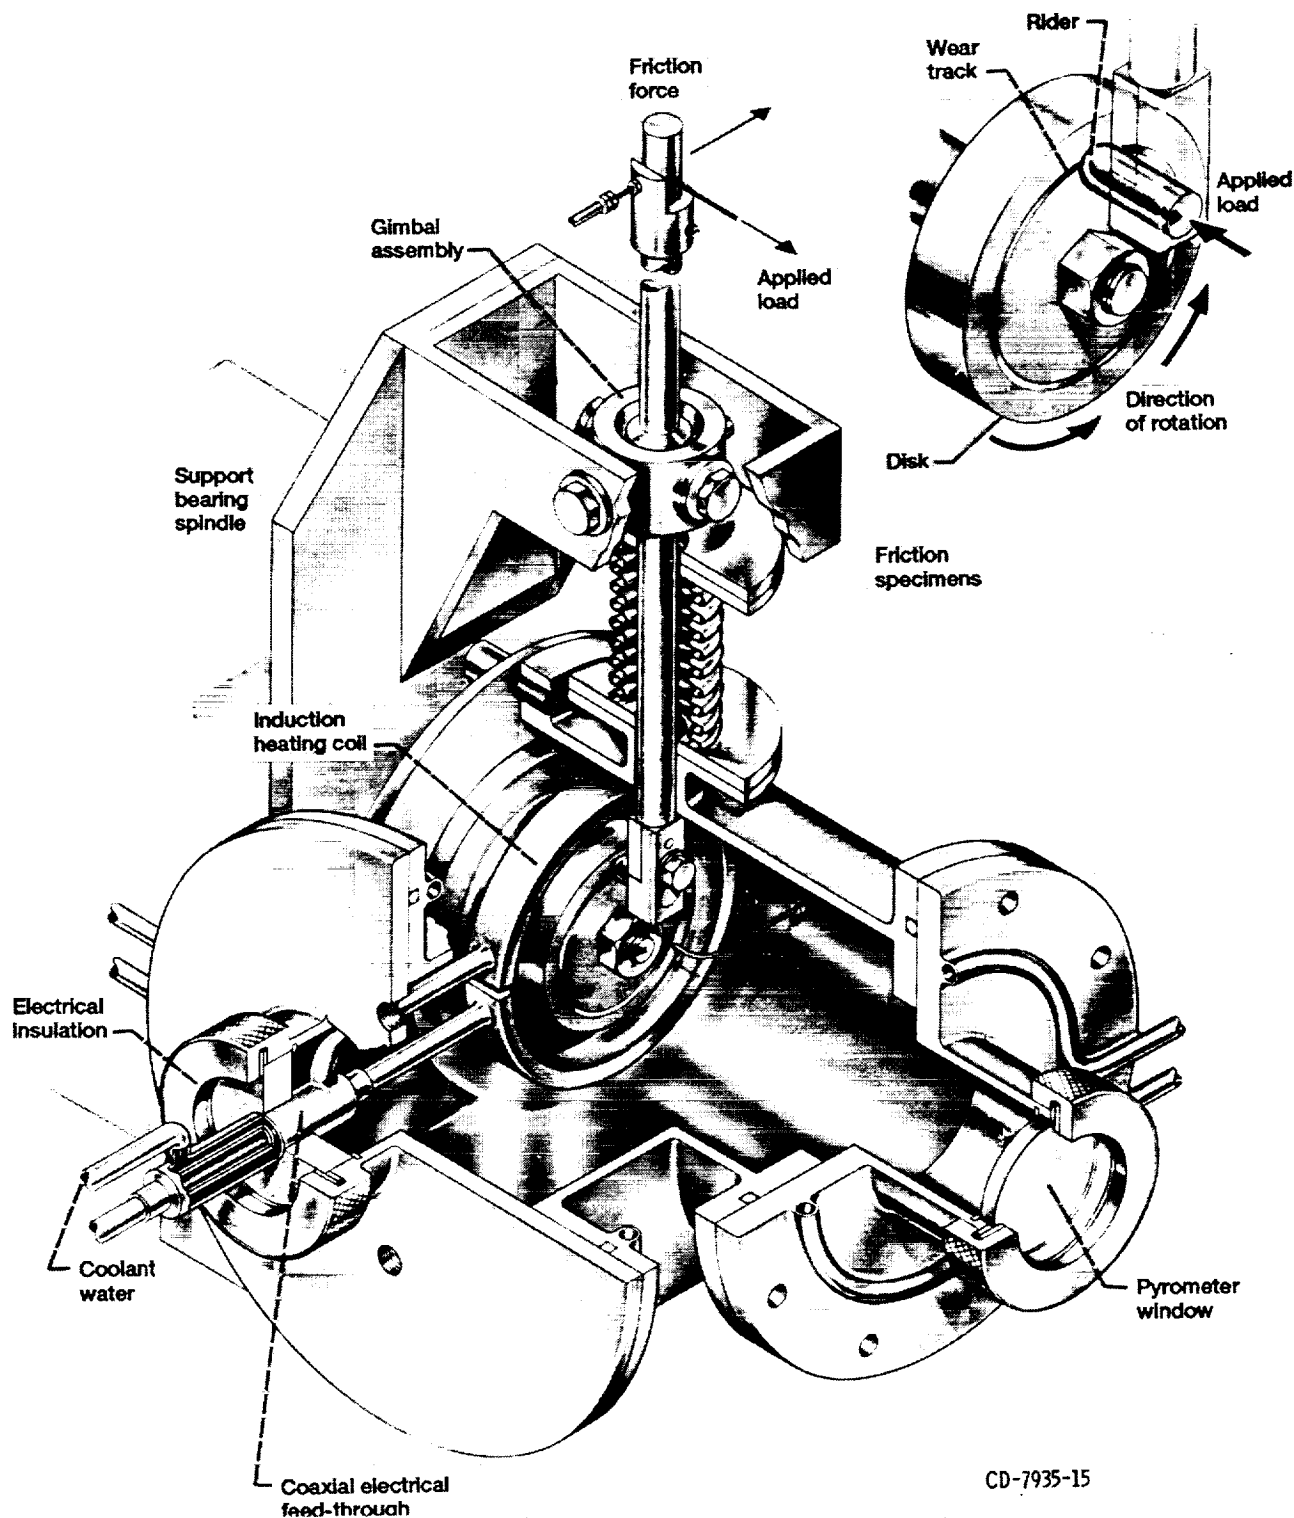
Figure 5.—High temperature pin on disk tribometer.

To test a fiber candidate, the pin is slid against a counterface disk in a high temperature pin-on-disk tribometer. The disk is 63.5 mm in diameter and 12.7 mm thick. The pin generates a 51-mm wear track on the face of the disk. Figure 5 shows a schematic of the tribometer used in this work.

The pin-on-disk tribometer heats the specimens using an induction heating coil to achieve the desired test temperatures. For the tests conducted here, the sliding speed was 0.025 m/s and the load was 0.270 kg. Test temperature was 25, 500, and 900 °C and measured using infrared pyrometry and contact thermocouples. The chamber atmosphere during these tests was technical grade hydrogen (nominal composition: 99.95 percent H₂, N₂ < 400 ppm, H₂O < 50 ppm, O₂ < 50 ppm) flowing at 7.1×10^{-3} m³/min. Prior to introducing H₂ into the chamber, Argon was used for purging. The test chamber pressure was maintained at 2 psig throughout the tests. The test duration was 120 min. Friction was continuously measured during the tests. Wear was quantified after each test using visual and SEM analysis. Previous tests indicated that fiber wear occurs in a fairly uniform manner during the tests. That is, the wear rate is more or less constant over the entire test suggesting that interfiber friction and load sharing effects are small (ref. 2).

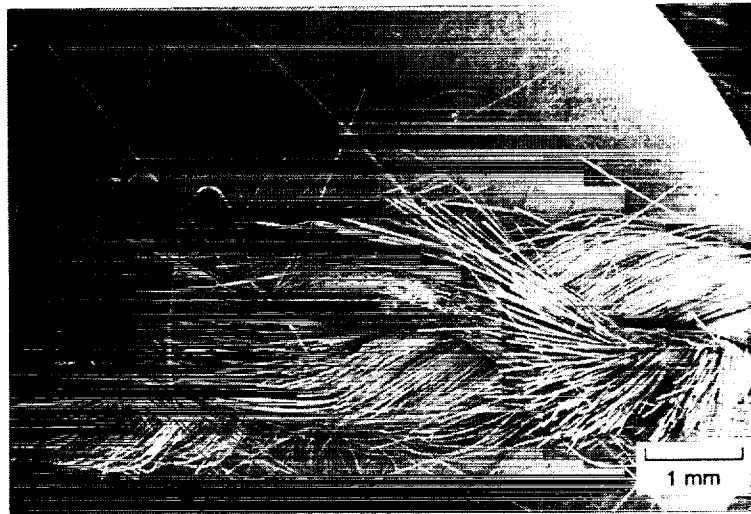
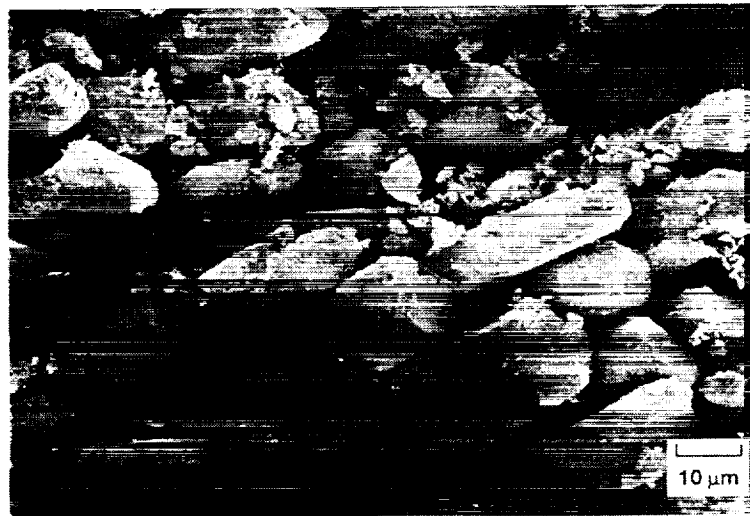
Figure 7.—SEM photomicrographs of complex carboxynitride fiber, HPZ, after sliding in H₂ at 25 °C. Sliding surface features include abraded regions and faceted fracture regions.

The wear surfaces of the fiber specimen bundles (tows) and counterface disks were examined with a Scanning Electron Microscope, SEM, to better understand the measured wear behavior. Figures 6 to 9 show both oxide fibers and HPZ after sliding at temperatures from 25, 500, and 900 °C. At 25 °C, all of

the examined fiber wear surfaces exhibited characteristics of abrasive wear such as small particulate debris and faceted fractured failure surfaces. The disk wear tracks appear smoothed or smeared slightly with no evidence of severe material removal (fig. 10).

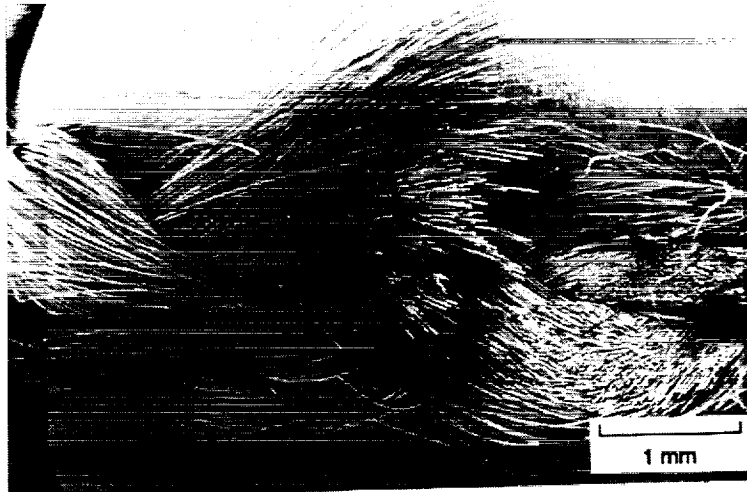
Figure 8.—SEM photomicrographs of Al_2O_3 - SiO_2 - B_2O_3 , Nextel 440, fibers after sliding in H_2 at 900 °C. Smooth, flattened, elliptical wear surfaces and small debris particles suggest mild abrasion occurred.

At 900 °C, the oxide fiber materials have wear surfaces very similar to those observed at 25 °C except the wear surfaces are smoother suggesting more mild abrasive wear. The complex carbide fiber, HPZ, however, shows evidence of a reaction occurring at the sliding contact. This can be seen as severe blistering and bubbles present on the worn fiber surfaces. Blistering usually indicates the presence of a gas within the fiber being created or evolved and may be a contributing factor to the low durability of HPZ at 900 °C.

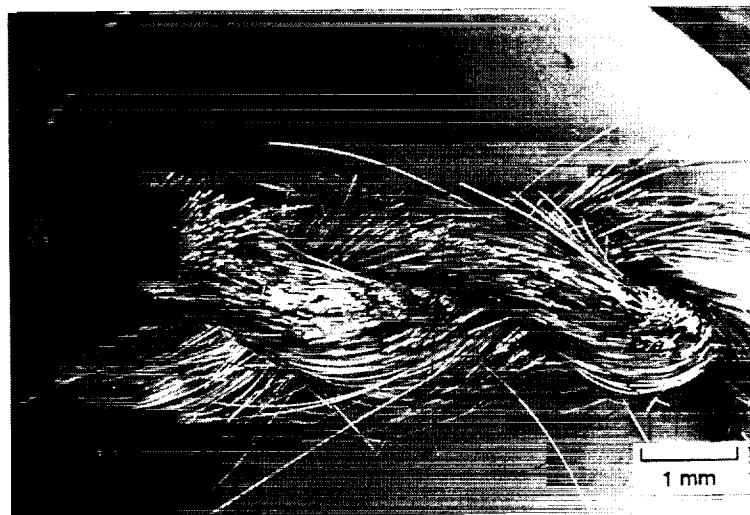
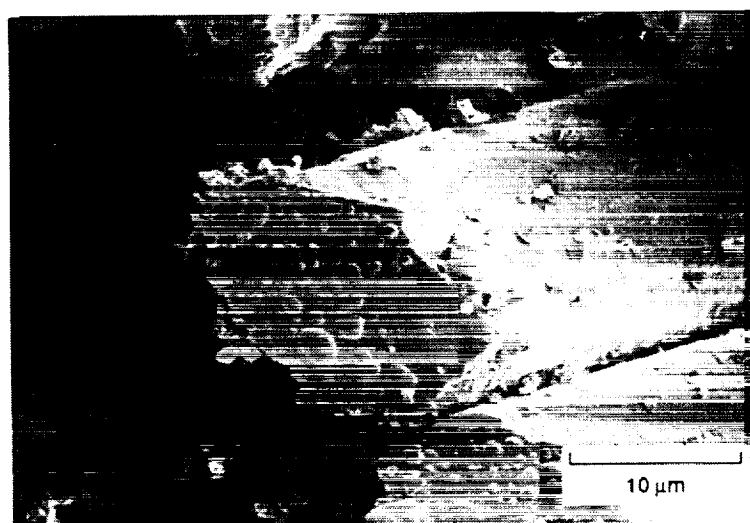
Figure 9.—SEM photomicrographs of complex carboxynitrile fiber, HPZ, after sliding in H_2 at 900 °C. Note blistering on sliding surfaces.

leading to enhanced attack of the HPZ by the hydrogen. The wear features, observed for HPZ tested in H_2 at 900 °C, namely blistering shown in figure 9, suggest a reaction occurs creating a gas. A possible reaction presented by Misra is the production of methane, CH_4 , from the carbon in the fibers and the H_2 test gas. Although the exact reaction/degradation mechanism(s) is not known at this time, the changes observed at the sliding interface (i.e., blistering) may explain the significant drop in high temperature durability of HPZ fibers.
